*The Canals of Jefferson Parish*  
A NEW DESIGN VOCABULARY

## Concept Statement

# 1 Existing Conditions – The Problems

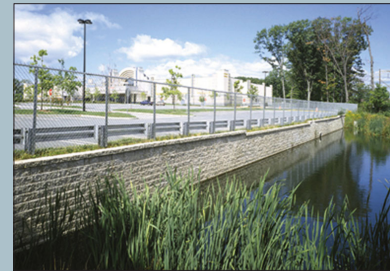
### B-1 SEGMENTAL RETAINING WALLS

Presently there are no SRWs along Canal#2. Replacement of aging wood and sheet pile wall systems with SRWs would, if done in a consistent way, enhance and modernize the appearance of the canal's banks.

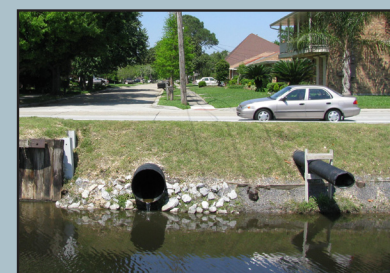
*This photo of existing drain outfalls shows two completely different treatments. The pipe on the left is similar to how all outfall locations could be treated - trimmed back close to the bank, with gabion or rip rap underneath.*

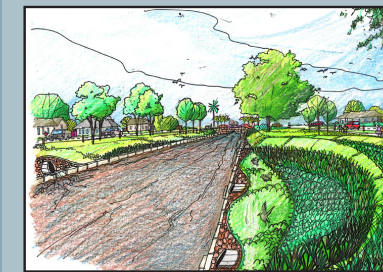
### D-1 STORM PIPE OUTFALL TREATMENT

Trim back drain pipe to the bank slope, beveling the edge to conform to the slope of the bank. Paint the pipes black for better concealment. Install rip rap or gabion mat beneath pipe to buffer outfall area from erosive action of stormwater.

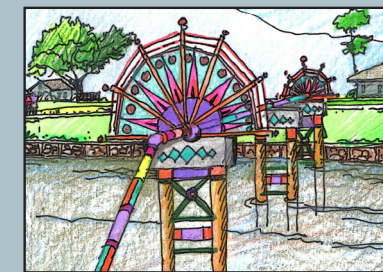
### D-2 UTILITY CROSSING TREATMENT

The most cost-effective option would be to keep the utility crossings in place, but address the aesthetics of the pipes and supports. All pipes and parts could be painted black, supports could be simple, using clean lines instead of clunky, heavy pilings.

Alternatively, all pipes and parts could be painted thematically, or even have sculpture mounted on the pipes. An art competition approved by governing agencies could award designs to local artists.

Utility pipes crossing the canal could be jacked and bored and run underneath the canal. They also could be buried and routed around the canal, crossing underneath existing vehicular bridges, where they would again be buried until they rejoined the pipe or conduit. These solutions represent major infrastructure investments if done on a large scale.

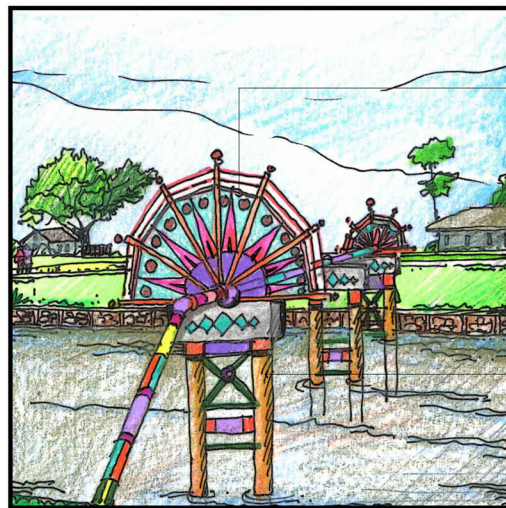
5 **DECORATIVE PIPE CROSSING** : AT SELECT LOCATIONS:

- DECORATIVE UTILITY CROSSING ART - TREATMENT 'D-2' (REF: REPORT)
- HIGHLY RIBBED AESTHETIC METAL SHEET PILING - TREATMENT 'B-2' (REF: REPORT)
- CANAL PIPE CROSSING ART TO BE DETERMINED BY CONTRACTED ARTIST - THIS IS A COLORFUL INTERPRETATION OF WHAT THE PIPE ART COULD RESEMBLE.
